**Flood Control Project Maintenance
Levee Inspections**

Fall 2012 Levee Maintenance Deficiency Summary Report

Reclamation District No. 0150 Merrit Island

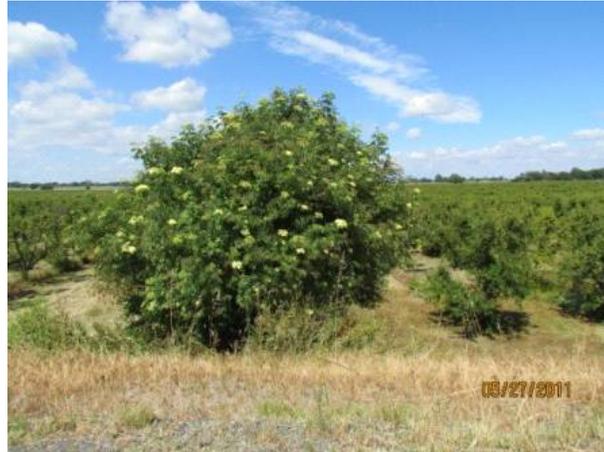
Levee Mile Report Line	1
Start Levee Mile	0.20
End Levee Mile	0.20
Location	Land Side
Category	Earthen Levee
Item	Vegetation
<p>Elderberry tree was found on the landside of the levee. The picture was taken from the crown looking downstream.</p>	
<p>pkazi_f_20120913_600.jpg</p>

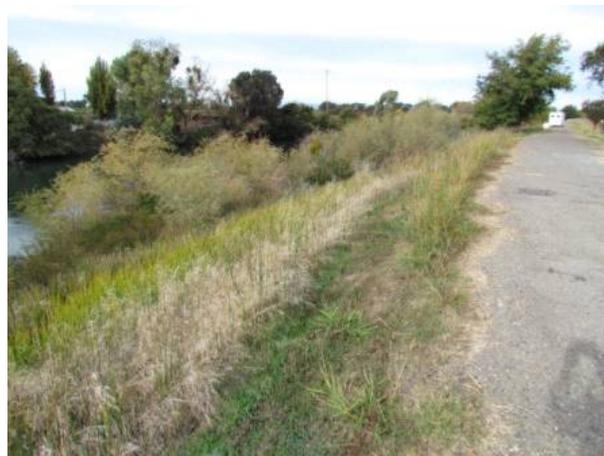
Levee Mile Report Line	2
Start Levee Mile	0.41
End Levee Mile	0.51
Location	Water Side
Category	Earthen Levee
Item	Vegetation
<p>Vegetation was found on the waterside of the levee looking upstream.</p>	
<p>pkazi_f_20121102_999.jpg</p>

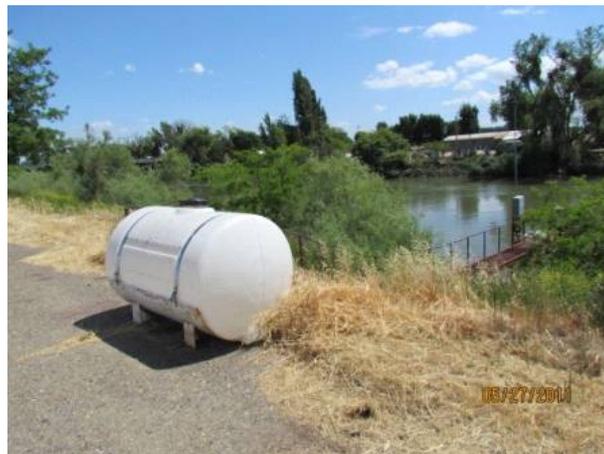
Levee Mile Report Line	3
Start Levee Mile	0.45
End Levee Mile	0.45
Location	Water Side
Category	Earthen Levee
Item	Encroachments
<p>A water tank was found on the waterside of the levee. The picture was taken from the crown looking downstream.</p>	
<p>pkazi_f_20120913_599.jpg</p>

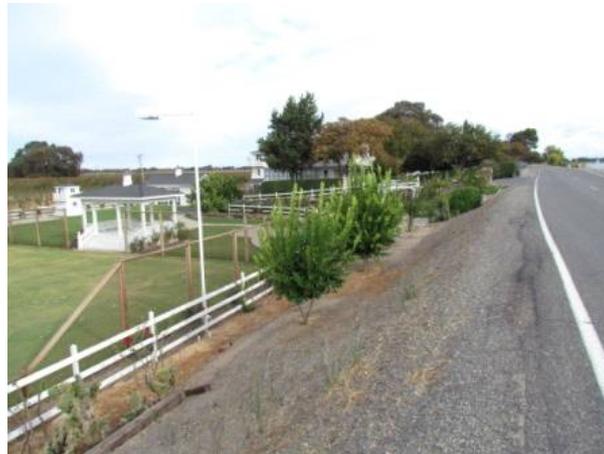
Levee Mile Report Line	3
Start Levee Mile	0.17
End Levee Mile	0.21
Location	Land Side
Category	Earthen Levee
Item	Vegetation
Landscaping was found on the landside of the levee looking upstream.	
pkazi_f_20121102_001.jpg

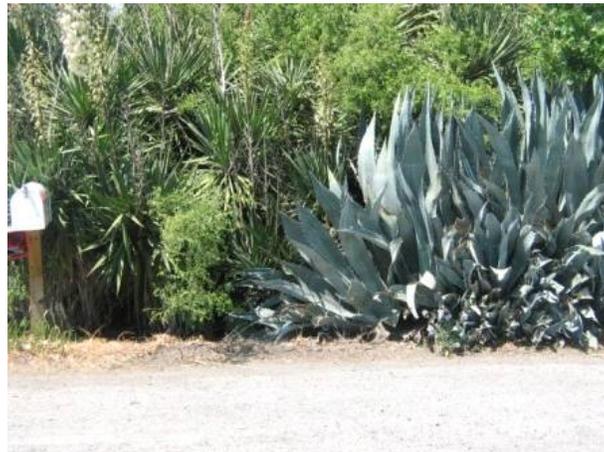
Levee Mile Report Line	5
Start Levee Mile	0.25
End Levee Mile	0.25
Location	Land Side
Category	Earthen Levee
Item	Vegetation
Landscaping on landward slope at LM 0.25 blocking view of levee slope.	
pkazi_f_20120913_603.jpg

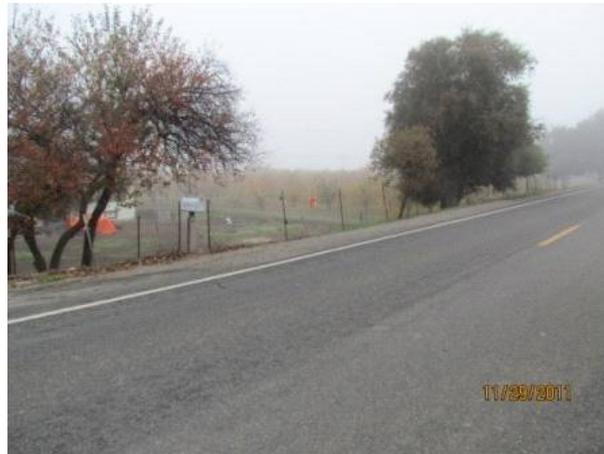
Levee Mile Report Line	7
Start Levee Mile	0.34
End Levee Mile	0.34
Location	Land Side
Category	Earthen Levee
Item	Encroachments
Fence was found on the landside of the levee looking upstream.	
pkazi_f_20120913_606.jpg

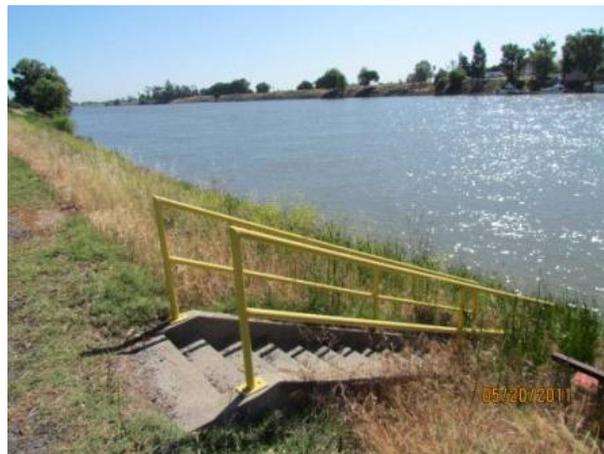
Levee Mile Report Line	8
Start Levee Mile	0.39
End Levee Mile	0.39
Location	Water Side
Category	Earthen Levee
Item	Encroachments
A stairway was found on the waterside of the levee. The picture was taken from the crown looking upstream.	
pkazi_f_20120913_609.jpg

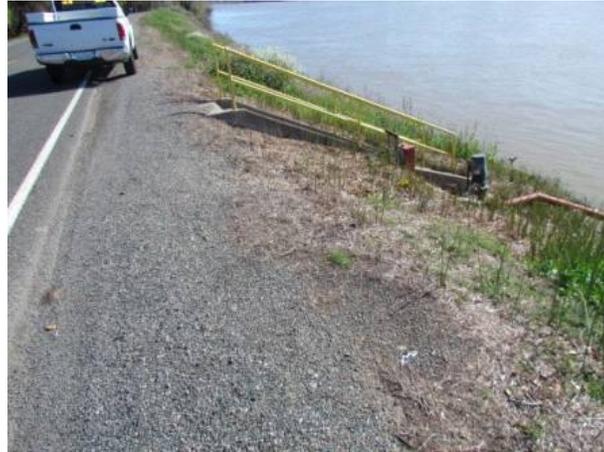
Levee Mile Report Line	9
Start Levee Mile	0.40
End Levee Mile	0.40
Location	Water Side
Category	Earthen Levee
Item	Slope Stability
Slope instability was found on the waterside of the levee looking upstream.	
pkazi_f_20120913_604.jpg

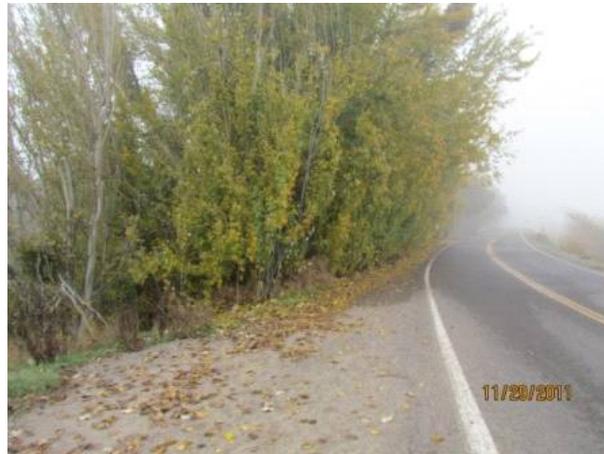
Levee Mile Report Line	16
Start Levee Mile	1.34
End Levee Mile	1.37
Location	Land Side
Category	Earthen Levee
Item	Vegetation
Landscaping was found landside of the levee looking upstream.	
pkazi_f_20120913_645.jpg

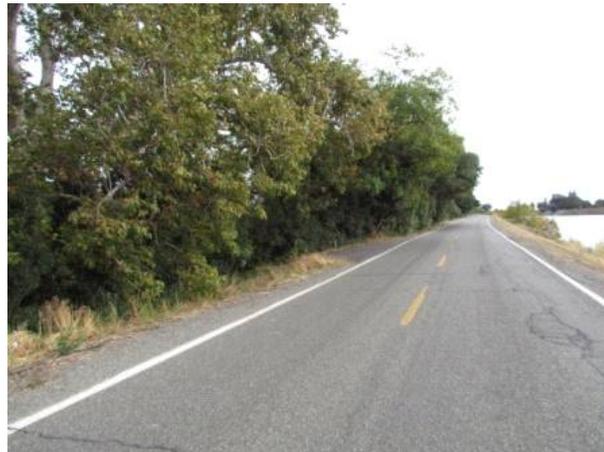
Levee Mile Report Line	17
Start Levee Mile	2.20
End Levee Mile	2.26
Location	Land Side
Category	Earthen Levee
Item	Trim / Thin Trees
Tree was obstructing the visibility on the landside of the levee looking upstream.	
pkazi_f_20121102_002.jpg

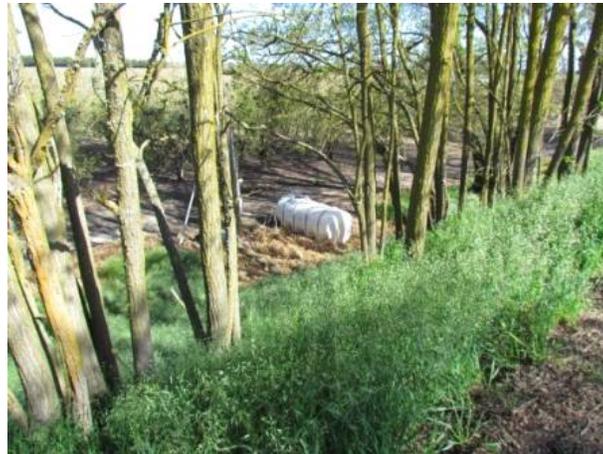
DWR ID: DWR_RD0150_02_s_2012_960										
20	2.75	2.75	Earthen Levee	Encroachments	LS	M En	TA : Tank Inspector Comments: Tank was found with the 10 feet of toe landside easement.	38.349542 ° -121.537451 °	38.349542 ° -121.537451 °	23 Y
DWR ID: DWR_RD0150_02_s_2012_23										
21	2.80	2.80	Earthen Levee	Trim / Thin Trees	LS	N Ma	T5 : Tree stumps.	38.350041 ° -121.536853 °	38.350041 ° -121.536853 °	14 Y
DWR ID: DWR_RD0150_02_s_2012_14										
22	2.82	2.82	Earthen Levee	Slope Stability	WS	C Ma	S3 : Repair the levee slope damaged by vehicle traffic and prevent access where possible.	38.350277 ° -121.536457 °	38.350277 ° -121.536457 °	1 Y
DWR ID: DWR_RD0150_02_s_2012_1										
23	2.82	2.82	Earthen Levee	Vegetation	LS	M En	V6 : Landscaping	38.350324 ° -121.536488 °	38.350324 ° -121.536488 °	16 Y
DWR ID: DWR_RD0150_02_s_2012_16										
24	3.02	3.06	Earthen Levee	Vegetation	LS	U En	V6 : Landscaping	38.352372 ° -121.534127 °	38.352802 ° -121.533638 °	85 Y

Levee Mile Report Line	20
Start Levee Mile	2.75
End Levee Mile	2.75
Location	Land Side
Category	Earthen Levee
Item	Encroachments
<p>A tank was found on the landside toe of the levee looking upstream.</p>	
<p>pkazi_f_20120913_617.jpg</p>

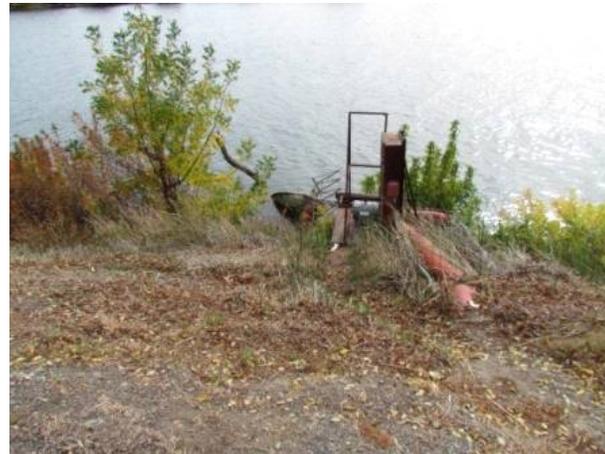
pkazi_f_20121102_003.jpg

View of erosion and damaged pipe and abandoned boat on the waterside of the levee looking upstream. This picture was taken during fall 2012 inspection.

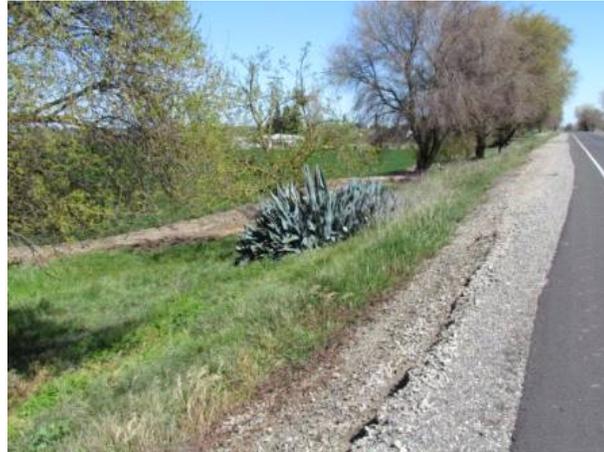
Levee Mile Report Line	52
Start Levee Mile	6.18
End Levee Mile	6.18
Location	Land Side
Category	Earthen Levee
Item	Vegetation
Century plant and vegetation was found on the landside of the levee looking upstream.	
pkazi_f_20120913_619.jpg

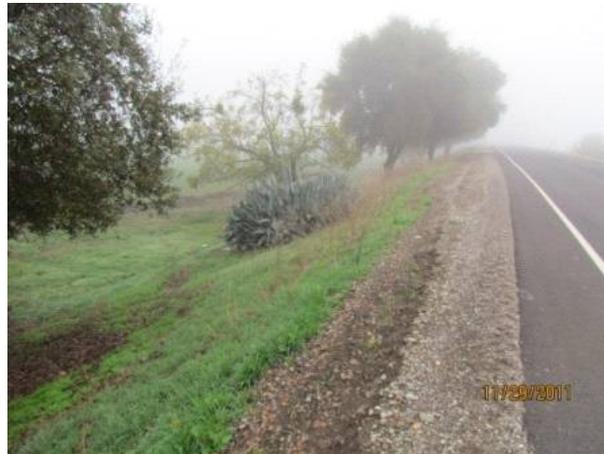
Levee Mile Report Line	53
Start Levee Mile	6.41
End Levee Mile	6.41
Location	Land Side
Category	Earthen Levee
Item	Vegetation
Century plant was found on the landside of the levee looking upstream.	
pkazi_f_20120913_620.jpg

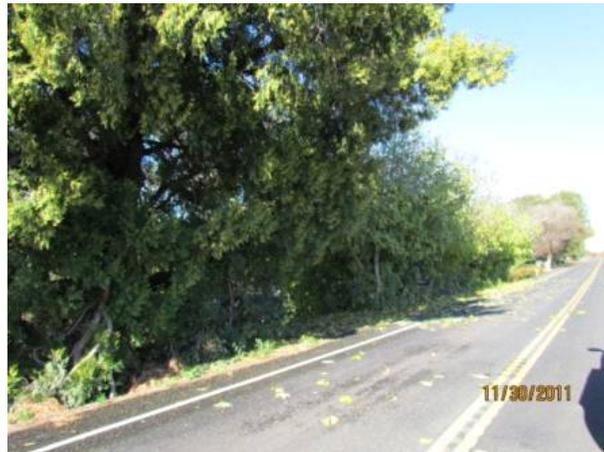
Levee Mile Report Line	56
Start Levee Mile	6.46
End Levee Mile	6.46
Location	Land Side
Category	Earthen Levee
Item	Vegetation
Trees need to trimmed on the landside of the levee looking upstream.	
pkazi_f_20120913_622.jpg

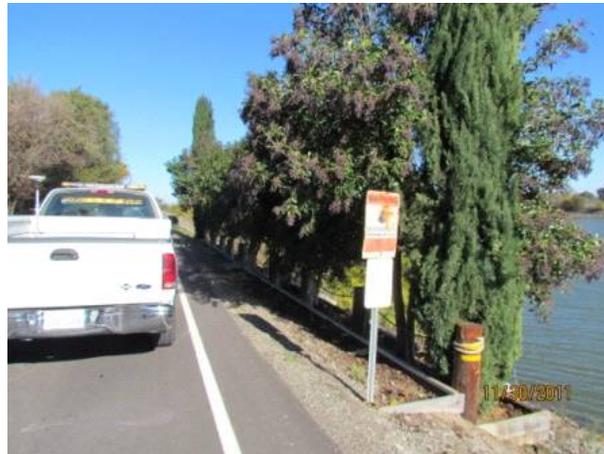
Levee Mile Report Line	58
Start Levee Mile	6.53
End Levee Mile	6.53
Location	Water Side
Category	Earthen Levee
Item	Vegetation

Landscaping was found on the waterside of the levee looking upstream.

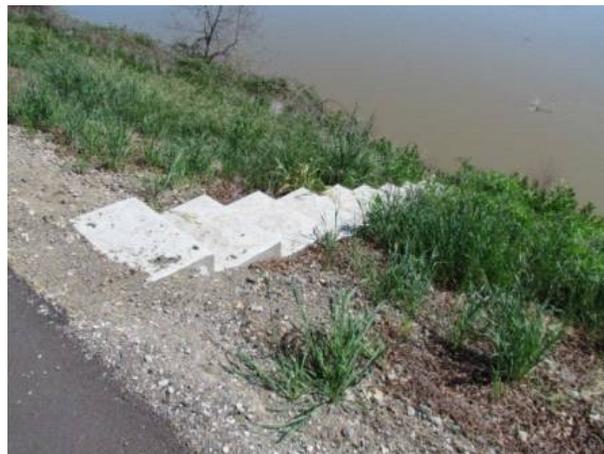
Levee Mile Report Line	59
Start Levee Mile	6.59
End Levee Mile	6.59
Location	Water Side
Category	Earthen Levee
Item	Encroachments

A stairway was found on the waterside slope of the levee looking upstream.

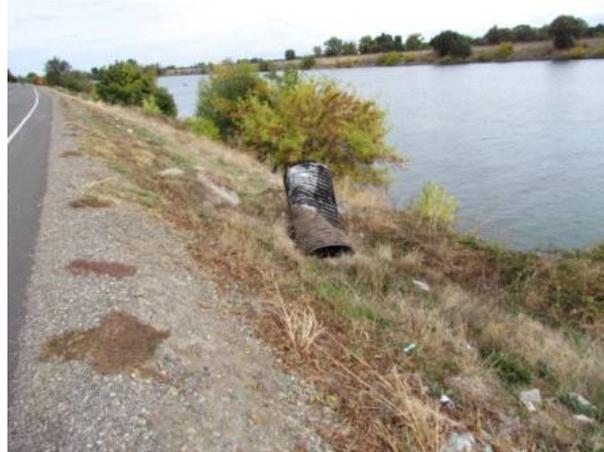
Levee Mile Report Line	60
Start Levee Mile	6.60
End Levee Mile	6.60
Location	Water Side
Category	Earthen Levee
Item	Encroachments
Debris was found on the waterside slope of the levee looking upstream.	
pkazi_f_20121102_010.jpg

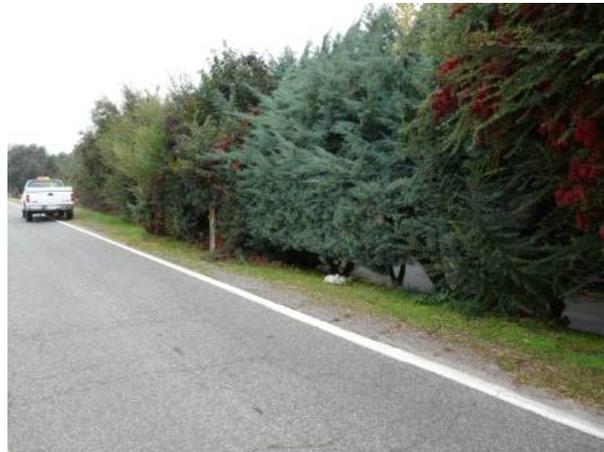
Levee Mile Report Line	61
Start Levee Mile	6.67
End Levee Mile	6.72
Location	Land Side
Category	Earthen Levee
Item	Vegetation
Landscaping providing a screen for a residence on landside of levee from LM 6.68 to LM 6.72	
pkazi_f_20120913_639.JPG

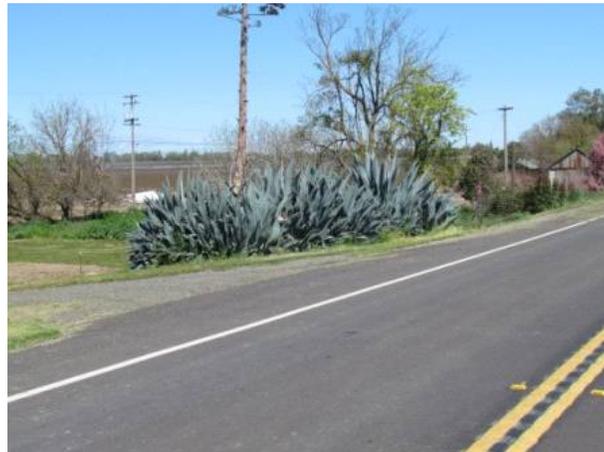
Levee Mile Report Line	62
Start Levee Mile	6.75
End Levee Mile	6.75
Location	Land Side
Category	Earthen Levee
Item	Vegetation
Century plants were found on the landside of the levee looking upstream.	
pkazi_f_20120913_629.jpg

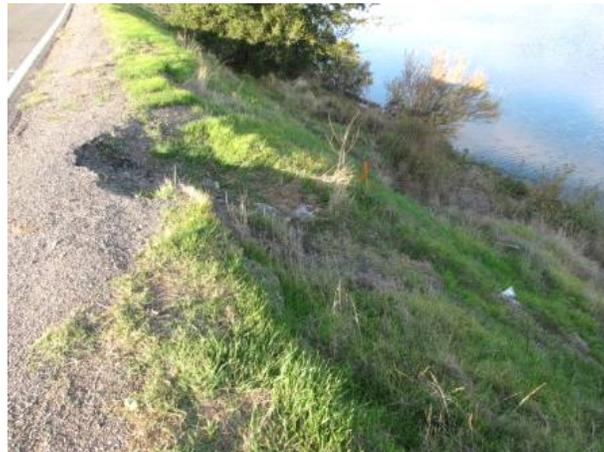
Levee Mile Report Line	68
Start Levee Mile	7.28
End Levee Mile	7.28
Location	Water Side
Category	Earthen Levee
Item	Slope Stability
View of minor erosion along the top portion of the waterward slope likely cause by foot traffic. The erosion has started to encroach into the shoulder of the road.	
pkazi_f_20120913_652.jpg

DWR ID: DWR_RD0150_02_s_2012_46										
68	7.28	7.28	Earthen Levee	Slope Stability	WS	M Ma	S2 : Repair the levee slope damaged by foot traffic and prevent access where possible.	38.405774 ° -121.517283 °	38.405774 ° -121.517283 °	968 Y
DWR ID: DWR_RD0150_02_s_2012_968										
69	7.34	7.34	Earthen Levee	Vegetation	LS	M Ma	V4 : Elderberries are blocking visibility and flood fight capability.	38.406454 ° -121.517732 °	38.406454 ° -121.517732 °	32 Y
DWR ID: DWR_RD0150_02_s_2012_32										
70	7.35	7.35	Earthen Levee	Slope Stability	WS	C Ma	S2 : Repair the levee slope damaged by foot traffic and prevent access where possible.	38.406607 ° -121.517739 °	38.406607 ° -121.517739 °	970 Y
DWR ID: DWR_RD0150_02_s_2012_970										
71	7.36	7.41	Earthen Levee	Trim / Thin Trees	LS	M Ma	T1 : Trim trees to at least five feet above ground level.	38.406817 ° -121.517687 °	38.407430 ° -121.518047 °	48 Y
DWR ID: DWR_RD0150_02_s_2012_48

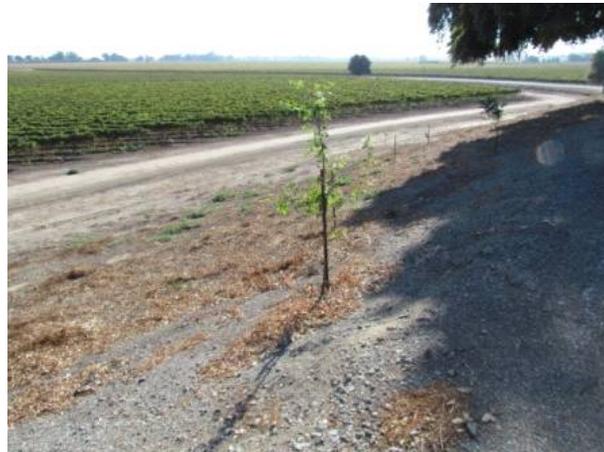
Levee Mile Report Line	13
Start Levee Mile	2.34
End Levee Mile	2.34
Location	Land Side
Category	Earthen Levee
Item	Encroachments
New tree was found on the landside shoulder of the levee looking downstream. This picture was taken during fall 2012 inspection.	
pkazi_f_20121101_998.jpg

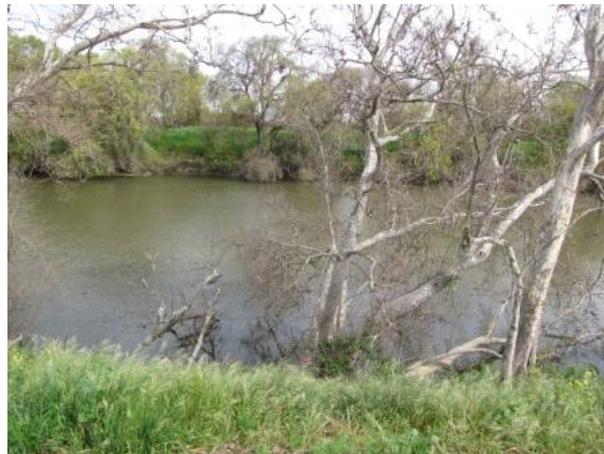
Levee Mile Report Line	20
Start Levee Mile	3.18
End Levee Mile	3.18
Location	Water Side
Category	Earthen Levee
Item	Trim / Thin Trees
View of tree stumps on the waterward slope.	
pkazi_f_20120913_676.jpg

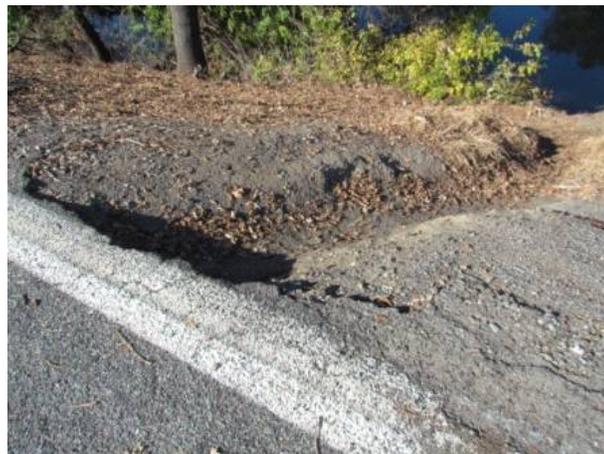
Levee Mile Report Line	32
Start Levee Mile	3.77
End Levee Mile	3.77
Location	Water Side
Category	Earthen Levee
Item	Slope Stability
Slope instability was found on the waterside of the levee looking downstream. This picture was taken during fall 2012 inspection.	
pkazi_f_20121101_995.jpg
